Service Bulletin	Revision 001
Warranty: Depends on Install Date	Diagnosing Noise Issues on Sporting Good Elliptical Trainers	Revised Date:
Time Required: 30 minutes	Serial Numbers Affected: All	Prepared by: Kevin Oeltjenbruns

DESCRIPTION

Noise issues arise after installation or after use.

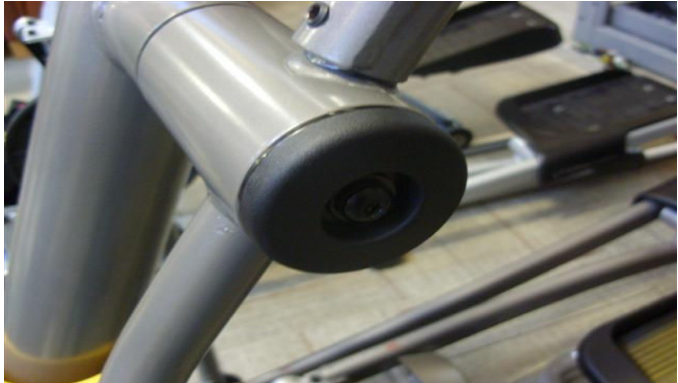
Figure E

3. Check the handlebar / console mast connection for a loose bolt (Figure E). Lubricate the shaft with lithium based grease (Figure F). This bolt should be torqued to approximately 6 N-m.

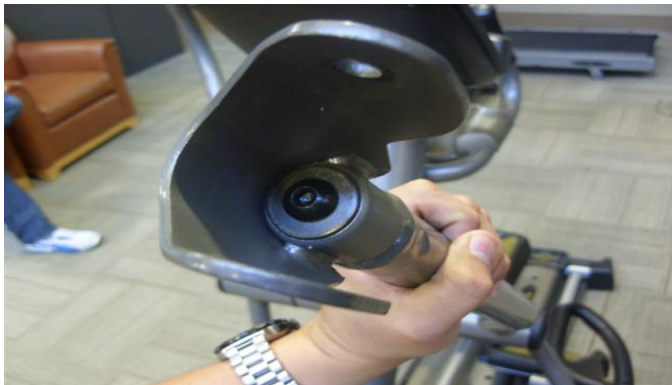
Figure G

4. Check the bolt holding the lower portion of the handlebar to the rest of the handlebar (Figure G). **NOTE:** On some models, this piece will be welded to the rest of the handlebar (like in Figure H), and does not need to be checked. This bolt should be torqued to 6 N-m.
